71-31-GP

FIELD EVALUATION OF TYPE 1, CLASS E, UNIT
LOADS TO DETERMINE CAUSES OF CORROSION
ON CANS OF NONPERISHABLE SUBSISTENCE

Anderson Miller

September 1970

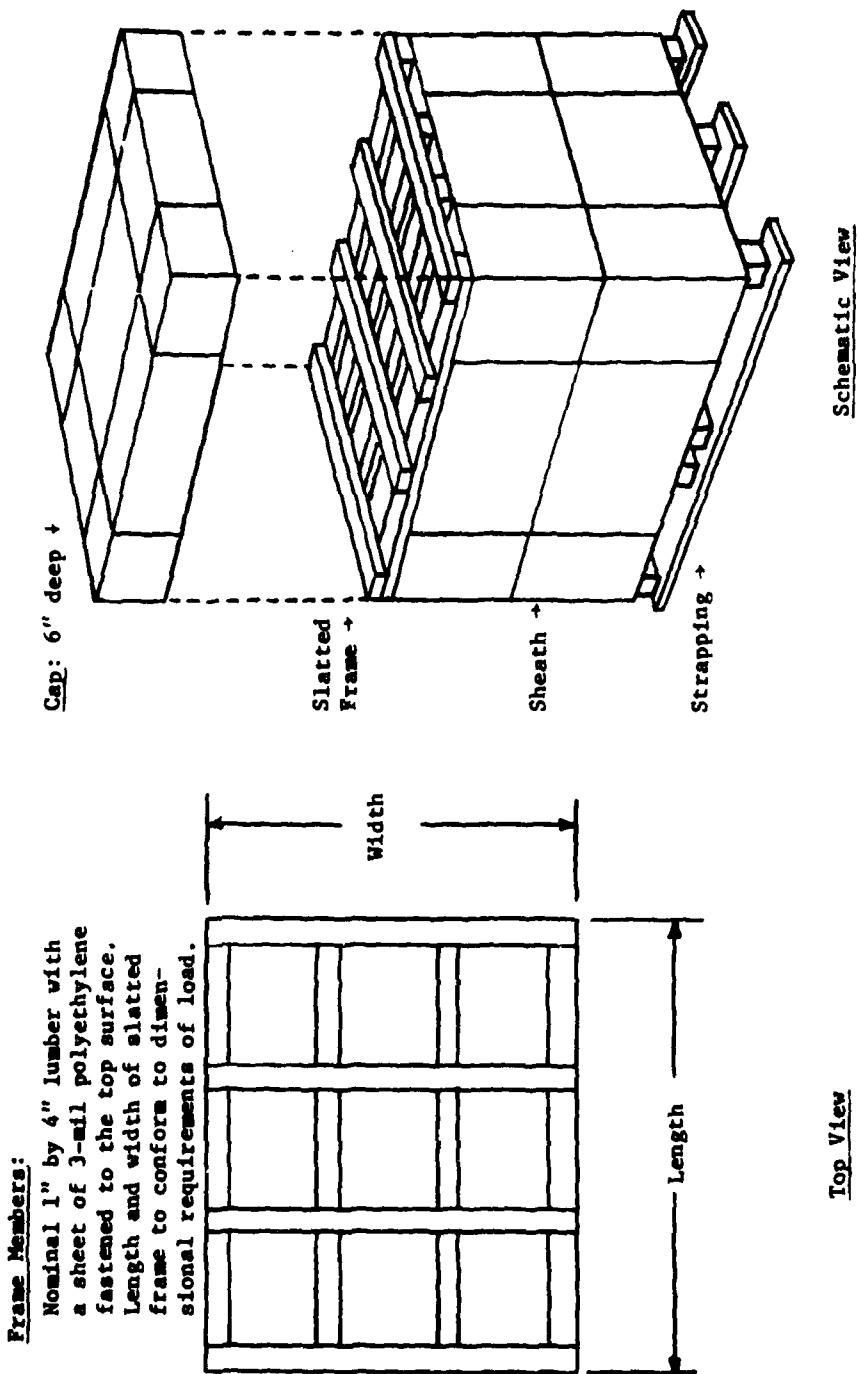
Same as Method 1, except that the polyethylene shroud was removed and a flat slatted wood frame 48" by 40" by 1-1/2" with a polyethylene sheet stapled to the top was placed under the cap. (See Figure 1.)

Figure 1. Slatted frame used for ventilating top layer of load.

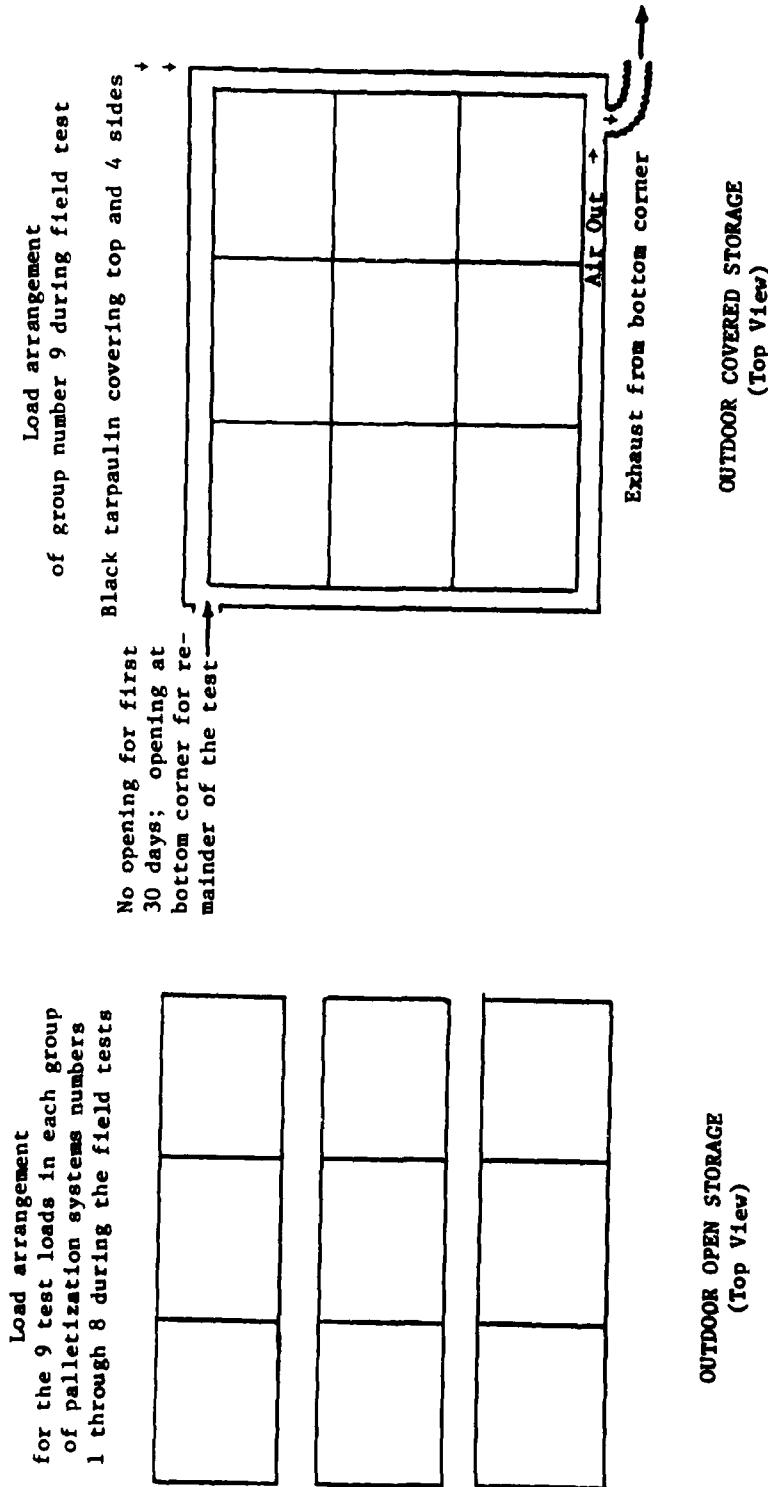
After the loads were prepared, they were moved to the outdoor storage site, and each of the groups of nine loads were divided into subgroups of three each. Each of the subgroups in palletization systems 1 to 8 was spaced approximately two feet apart, with the three loads adjacent to each other. All nine of the loads in the negative pressure system were placed in a three by three pattern adjacent to each other to facilitate the operation of the negative pressure system. (See Figure 2.)

Figure 2. Load arrangements of groups at test site for the outdoor exposure tests at Oakland, California.

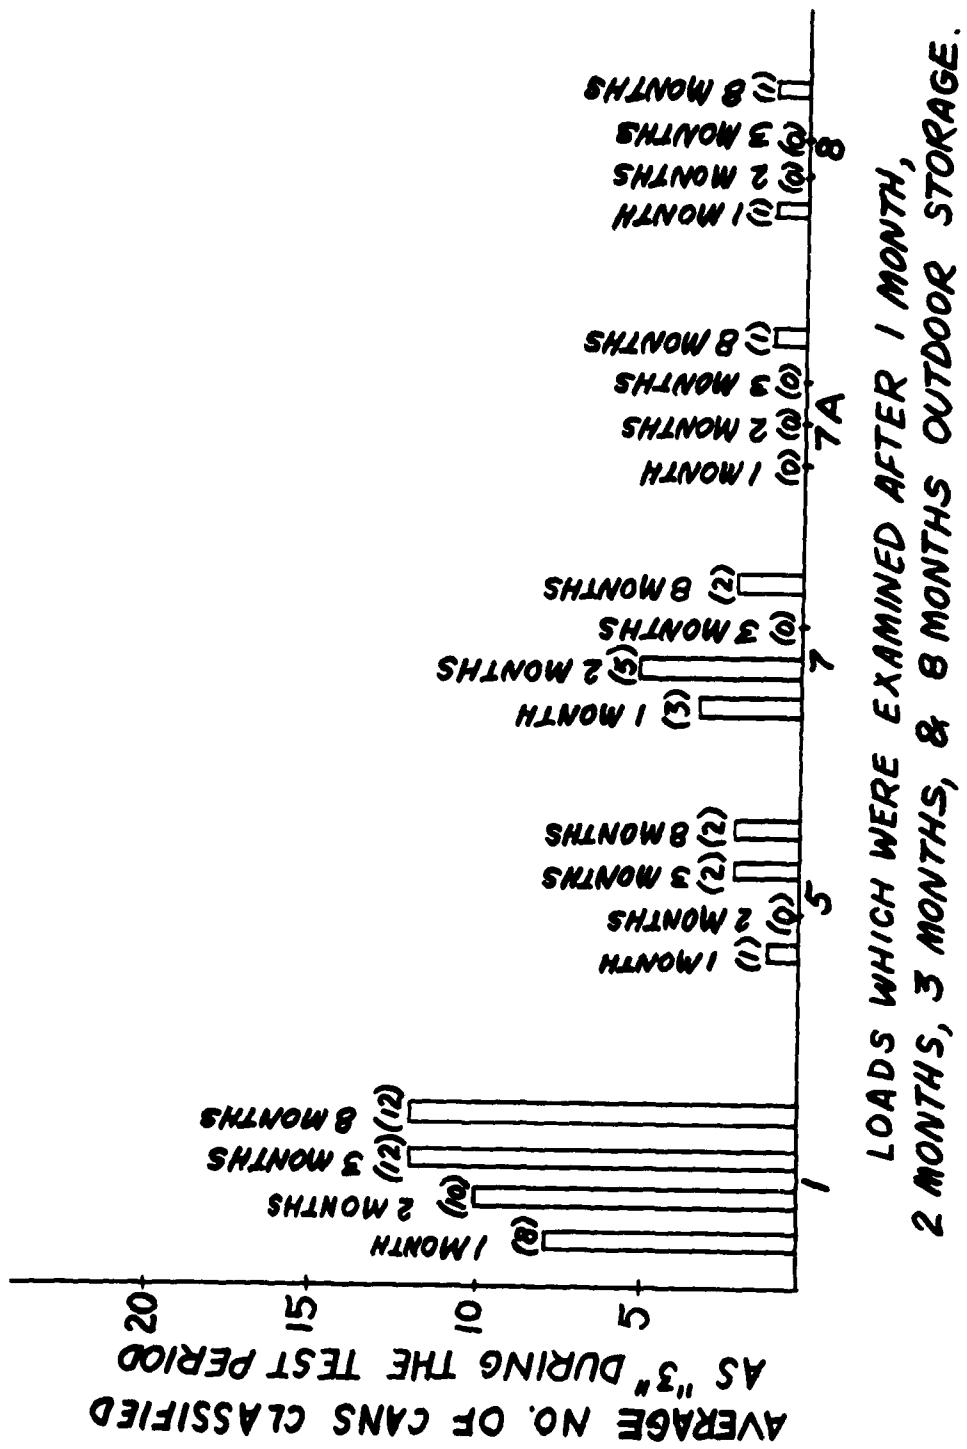
The results of the test after 90 days based on examination of the loads showed that the packaging methods which provided the best protection for the cans was 7A. Methods 5, 7, and 8 were equal and performed better than the remaining methods tested.

The final results of the findings in this study are shown in Figure 3. Detailed test results of the top layers are shown graphically in Appendix A. Temperature data are tabulated in Appendix B, as well as tabulated test results for all layers of the loads.

Figure 3. Bar graph showing condition of cans after each examination.
(Shown are average number of cans in the top layer of the loads which had sustained corrosion that was classified as "3" after each examination.)

The four methods for which the performance is considered satisfactory are (1) the loads with wax impregnated sheathing, (2) the ventilated V2s sheathed loads, (3) partially shrouded load with shroud over top layer only, and (4) V2s sheathed loads containing taped containers without the polyethylene shroud. These methods are selected based on the performance of all loads over the entire test period.

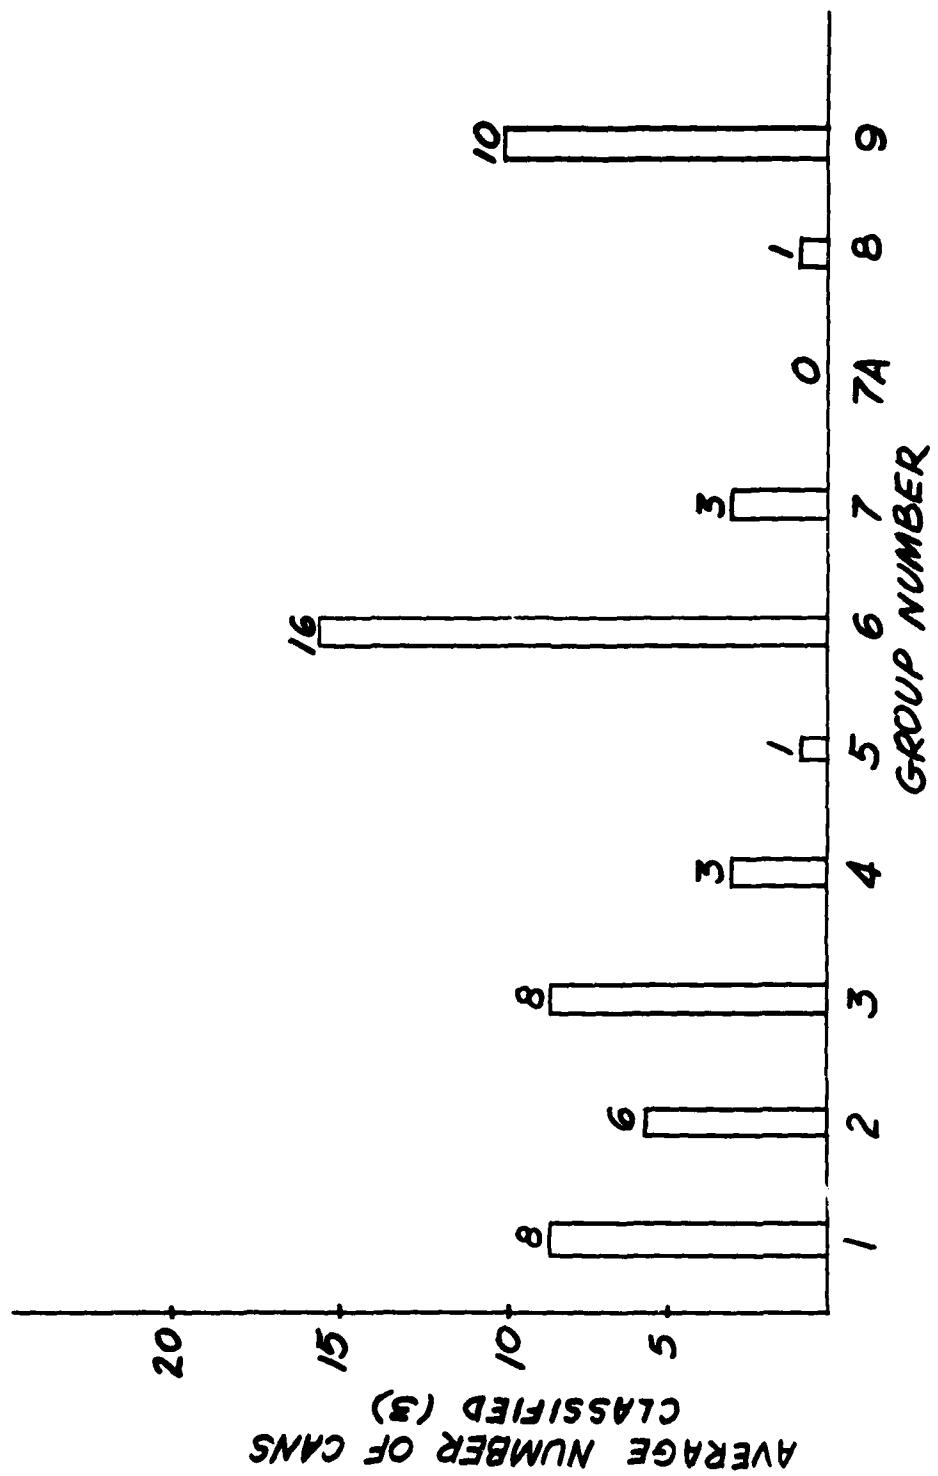
Figure 4. Average number of cans in the top layer of the loads which had sustained corrosion that had progressed to classification "3".
(Loads examined after 30 days.)

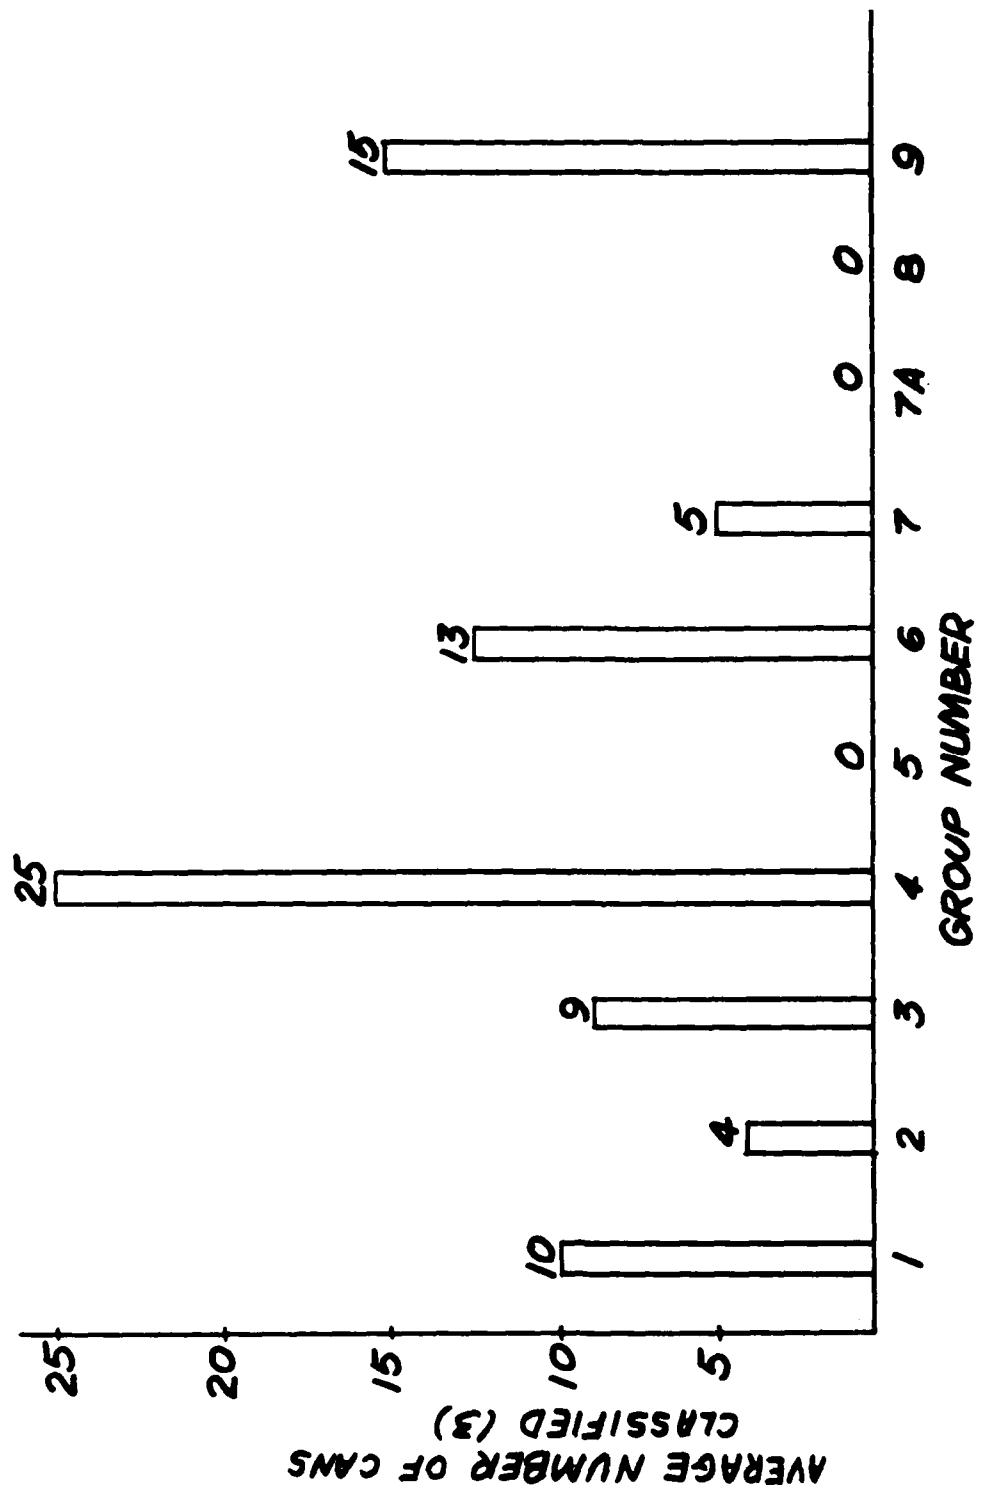
Figure 5. Average number of cans in the top layer of the loads which had sustained corrosion that had progressed to classification "3".
(Loads examined after 60 days.)

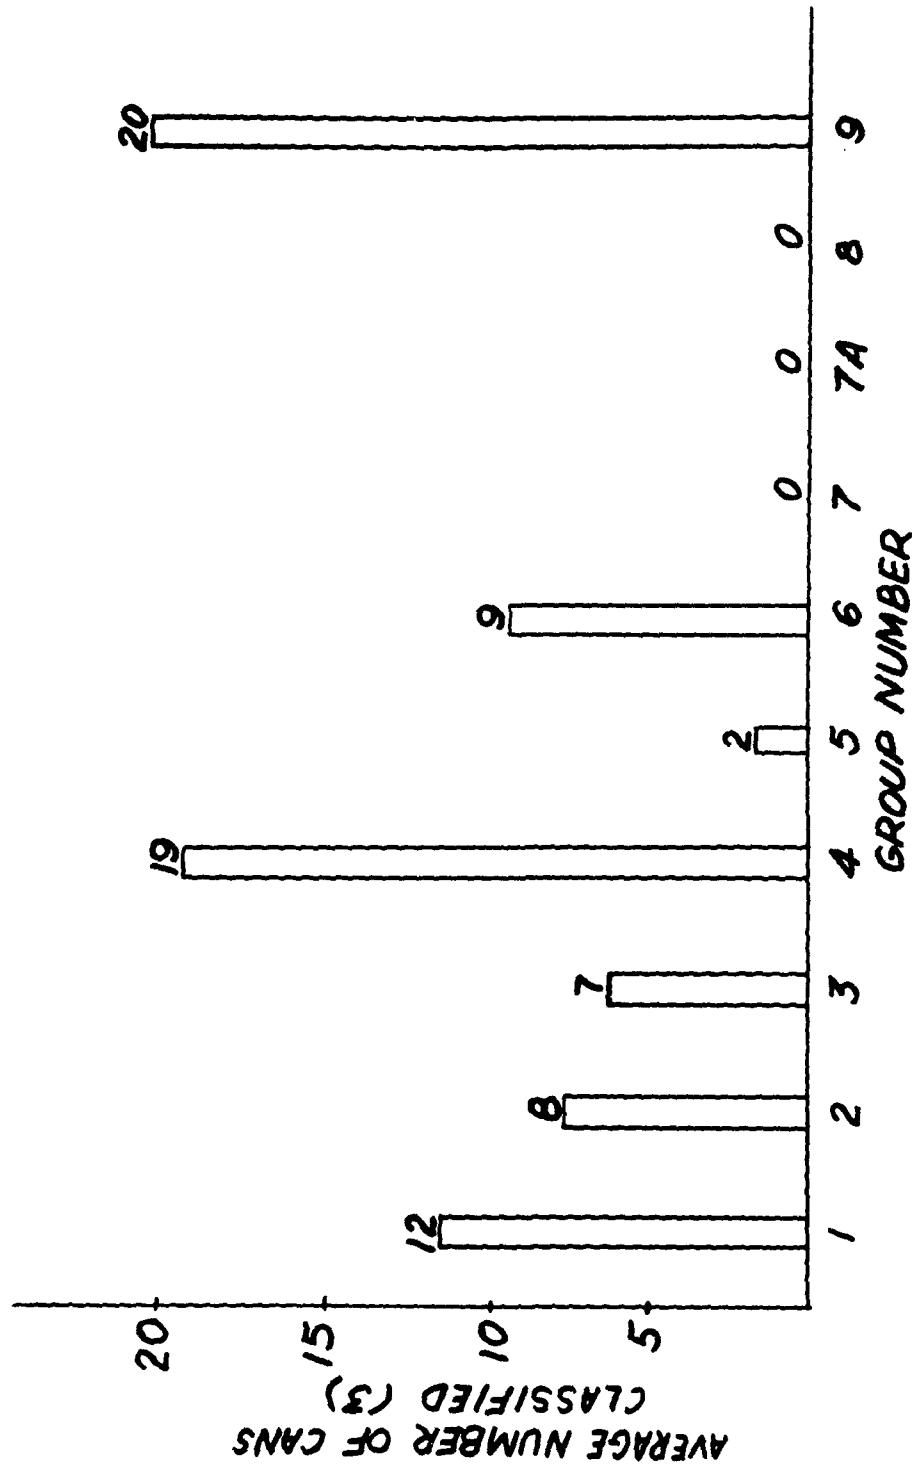
Figure 6. Average number of cans in the top layer of the loads which had sustained corrosion that had progressed to classification "3".
(Loads examined after 90 days.)

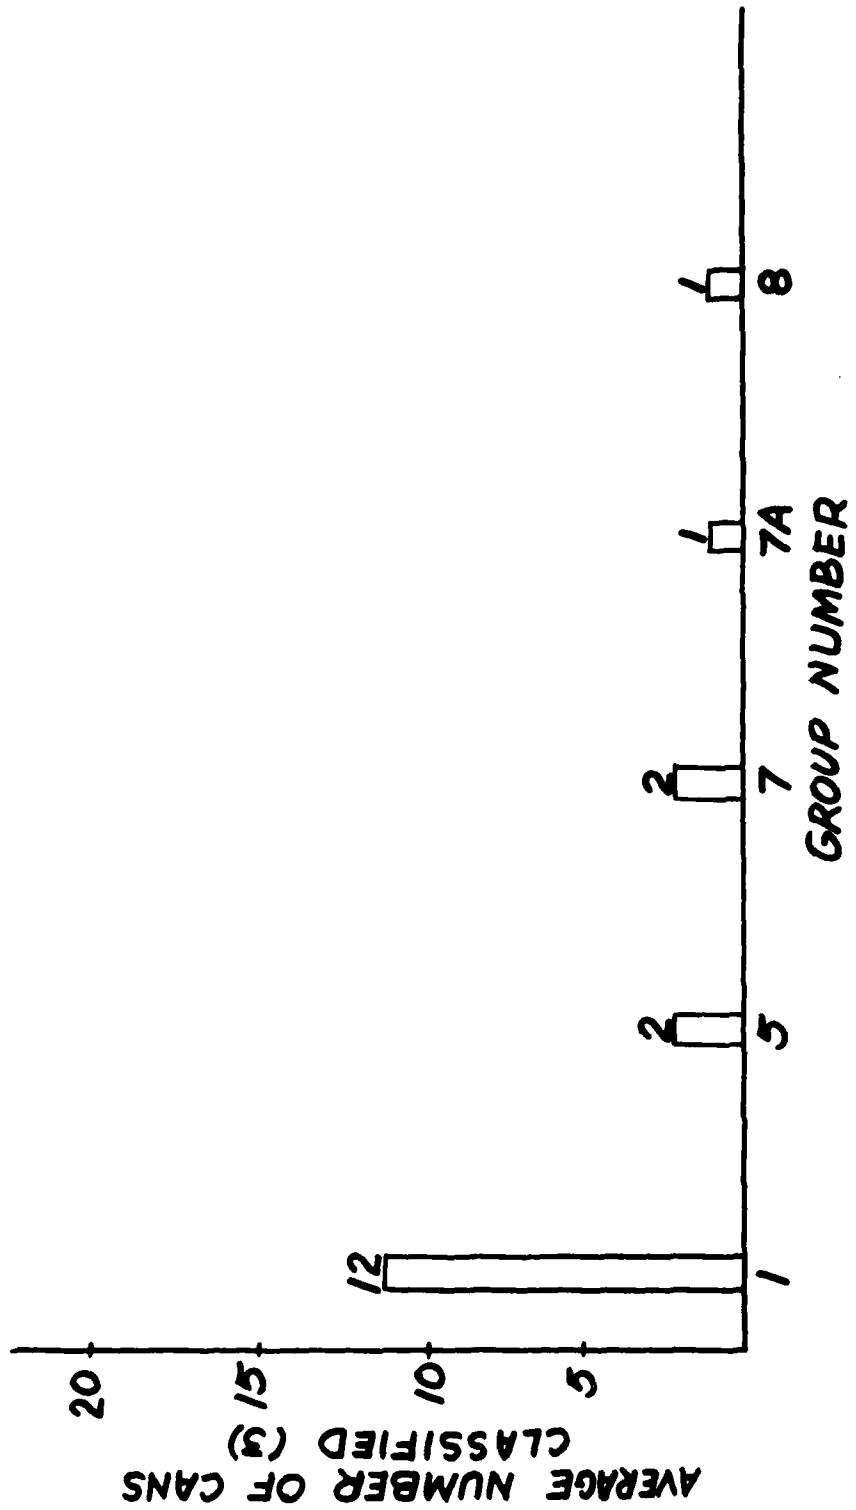
Figure 7 }
Results of the condition of the cans in the
top layer of the loads which were selected
to continue in the test for additional five
months. The graph shows the average number
of cans which had progressed to the "3"
classification over the extended test period.

Figure 7. Average number of cans in the top layer of the loads which had sustained corrosion that was classified as "3".
(Loads examined after 8 months.)

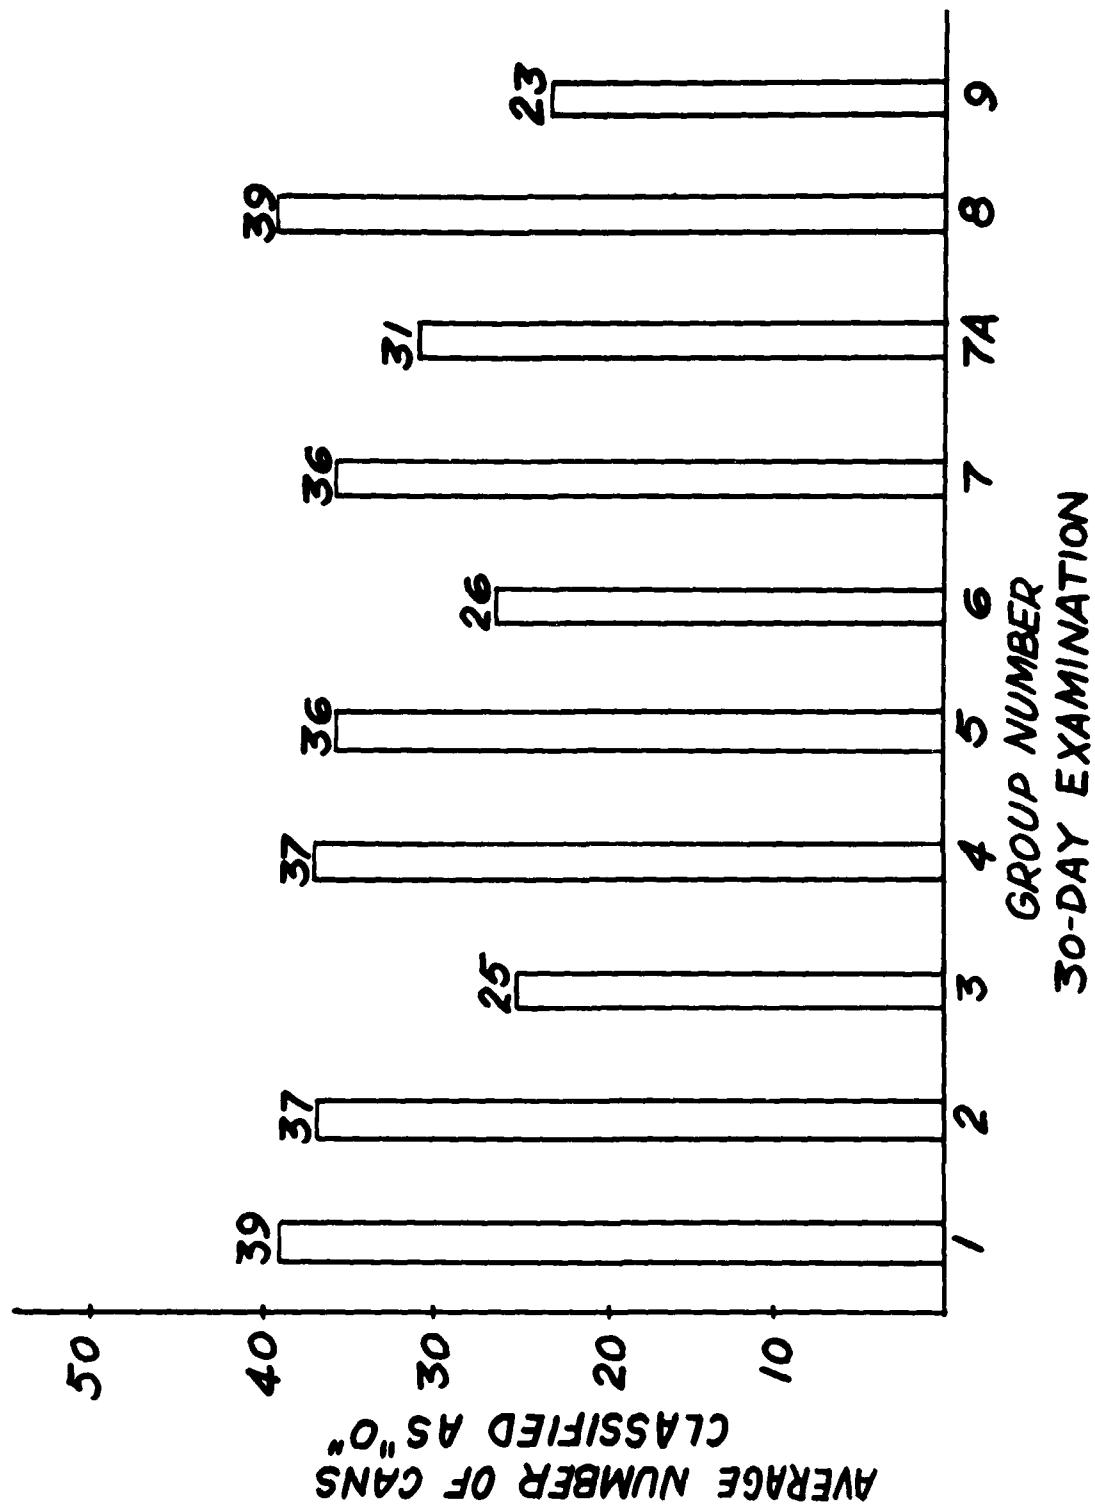
Figure 8. Average number of cans which were classified as "0" at the beginning of test - for the groups examined after 30 days.

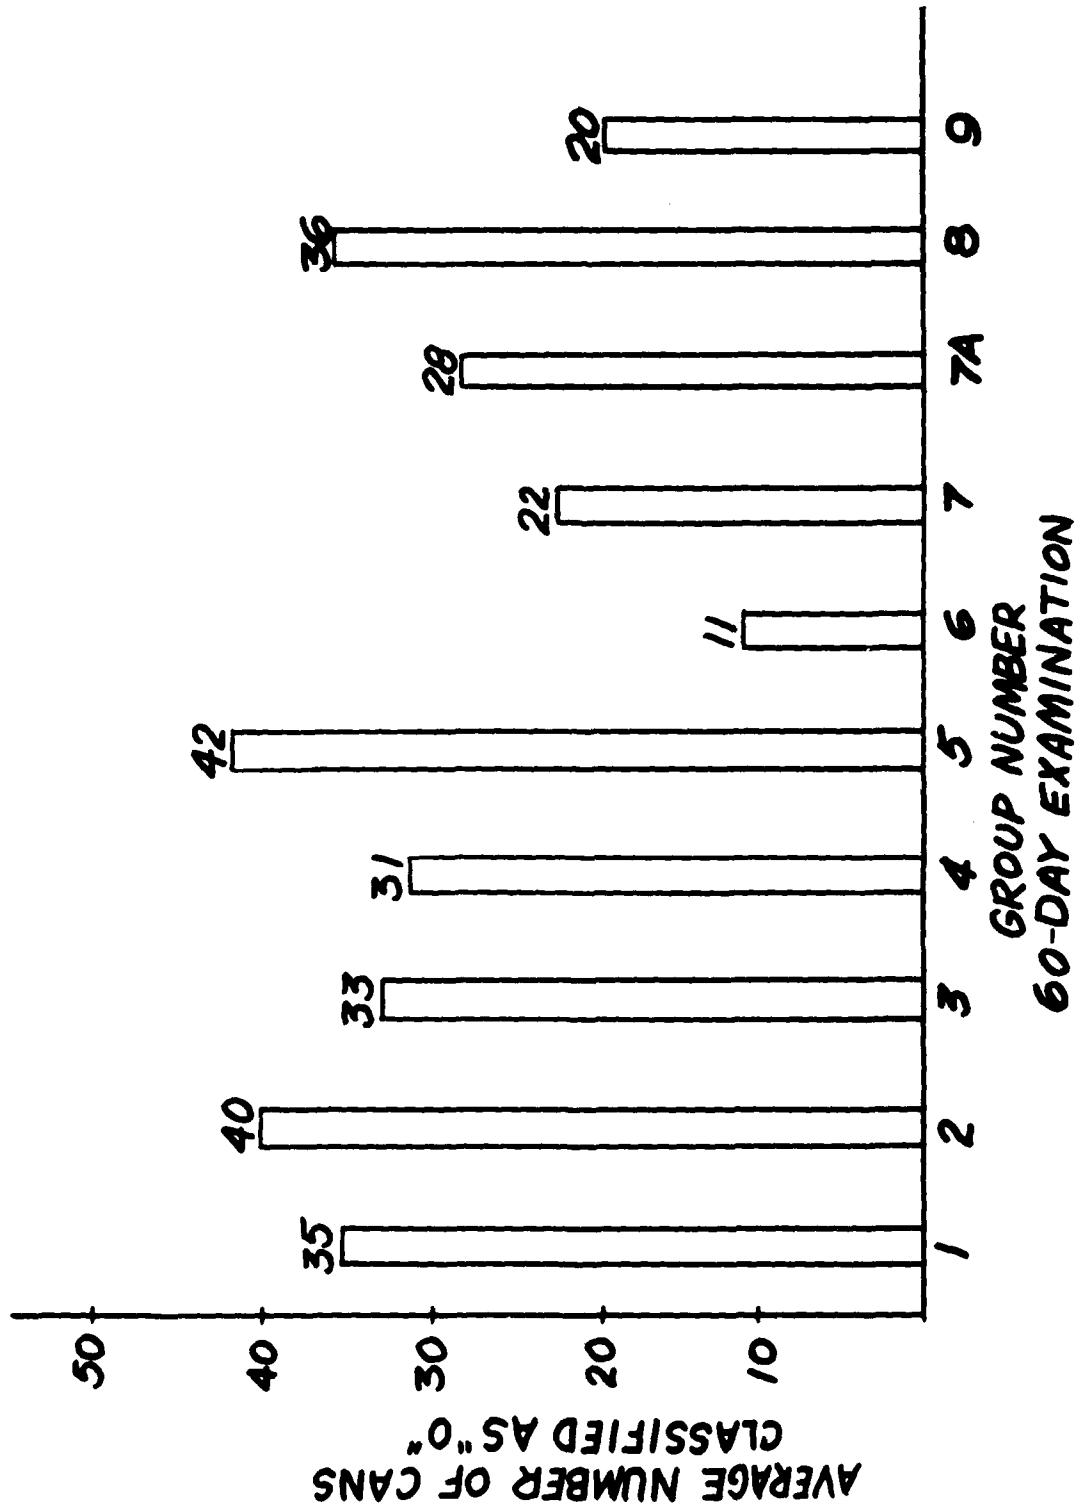
Figure 9. Average number of cans which were classified as "0" at the beginning of test - for the groups examined after 60 days.

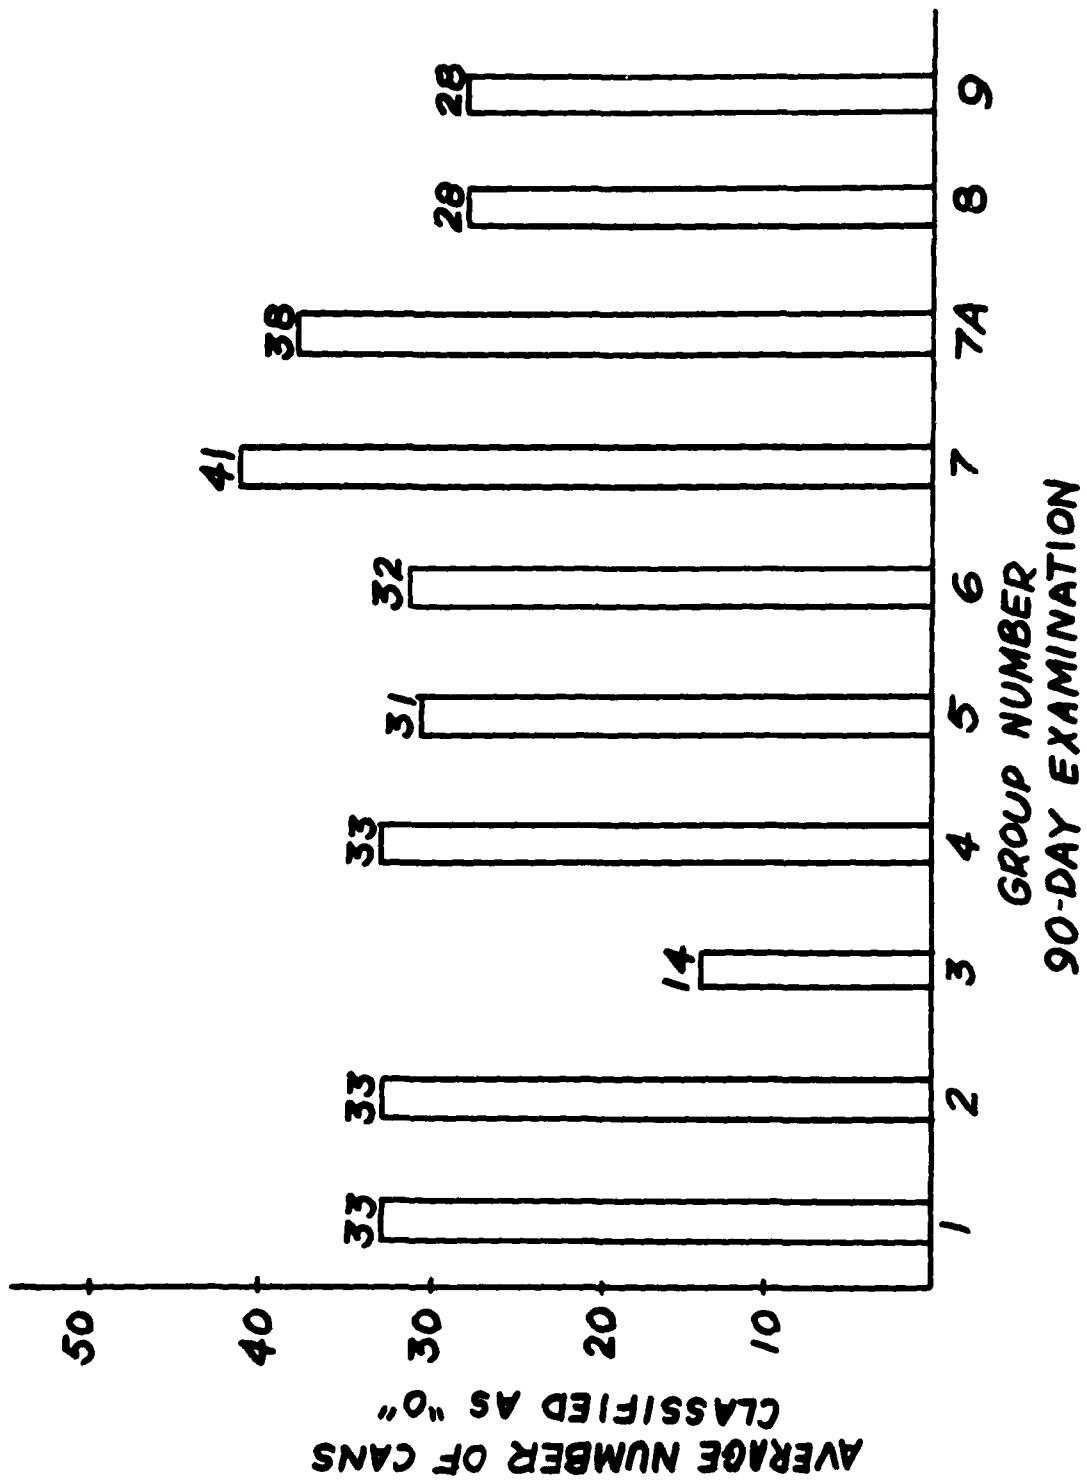
Figure 10. Average number of cans which were classified as "0" at the beginning of test - for the groups examined after 90 days.
